Operator's Manual

for DM100 VDR and DM100 S-VDR G2

Document Number	DBS11011
Version Number	2.0
Date	June 2019
P/N (hard copy)	9302721-20

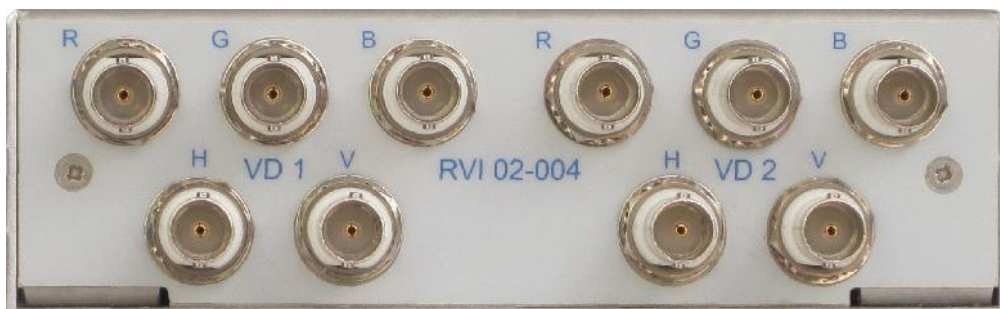
The DM100 may use RVI 02-004 and RVI 02-004D for image capture. The DM100 will power RVIs connected to the RVI or RDI port on the DAU. An RVI may be connected to a LAN port on the DAU if the RDI and RVI ports on the DPU are being used for other purposes. An AC power kit (p/n 2304449) will be required as the power source.

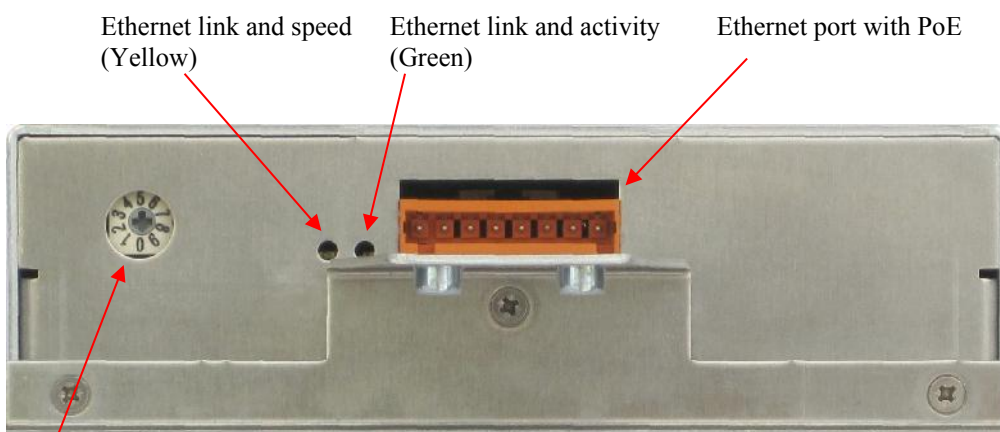
RVI 02-004(D) rear panel

The RVI address i.e. the rotary switch located behind the rear panel. Must be set to "0" for RVIs connected to the PoE ports on the DPU (labeled "RVI" or "RDI").
The RVI address must be set from 1 to 4 for locally powered RVIs (each locally powered RVI connected to the DM100 must have a unique RVI address).

484	RVI VIDEO Wrong RVI address	An AC powered RVI with incorrect RVI address has been detected. The RVI address must be 0 or 1. All RVIs connected to the VDR must be set up in the VDR configuration.
486	RVI VIDEO Module 3 missing	VIDEO module 3 cannot be detected. The most probable cause is that that the cable to the RVI from the DPU is disconnected or the RVI is defective. In addition, for an AC powered RVI: Power to the RVI is switched off, the internal Ethernet cable in the RVI is disconnected or the video interface module is defective.
488	RVI VIDEO Module 4 missing	VIDEO module 4 cannot be detected. The most probable cause is that that the cable to the RVI from the DPU is disconnected or the RVI is defective. In addition, for an AC powered RVI: Power to the RVI is switched off, the internal Ethernet cable in the RVI is disconnected or the video interface module is defective.

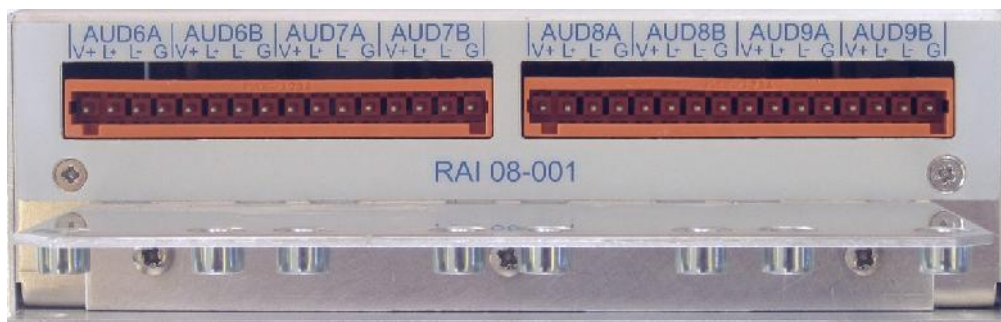
RAI 08-001

For some installations, a Remote Audio Interface is used for capturing additional audio signals from microphones and/or VHF sets.
